Alpha & Omega Home Inspections, LLC

Confidential Inspection Report

Property Address:
7834 Anystreet
MyTown NC

Date: 5/25/2010	Time: 09:15 AM	Report ID: Sample Report-High End Townhome
Property: 7834 Anystreet MyTown NC	Customer:	Real Estate Professional:

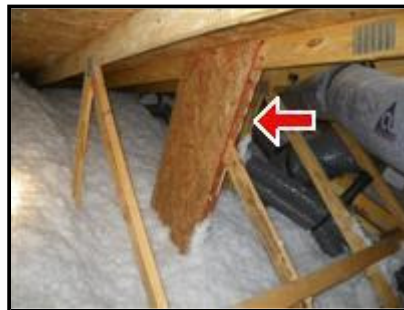
1.5 One or more trusses appear to have been modified--they were broken and have been repaired by splicing. We cannot determine if the repairs are adequate. Trusses are engineered structural members and any repair or modification should meet the manufacturer's specifications or else be conducted according to the specifications of a structural engineer. Stamped design drawings should exist demonstrating any repairs performed were approved by a licensed engineer. A recommendation is to attach design drawings to the truss to substantiate repairs when the house is sold in the future. We suggest that you consult with the builder, manufacturer of the trusses, or a structural engineer about the adequacy of the roof system's design. Reference documents about trusses and their repair are attached at the end of this report.

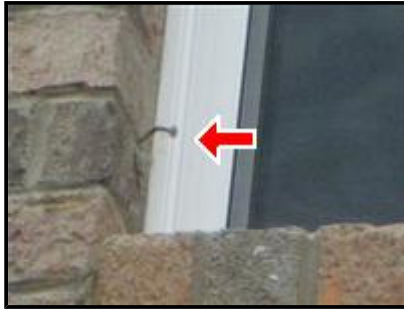
**2.1** A nail protrudes from the wall at a 2nd level rear window and should be removed for aesthetic reasons.

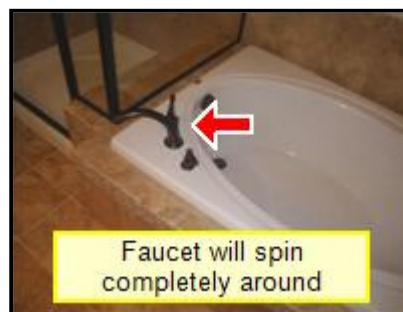
(2) The master bathroom bathtub faucet is loose and should be secured, as movement may contribute to leaks.

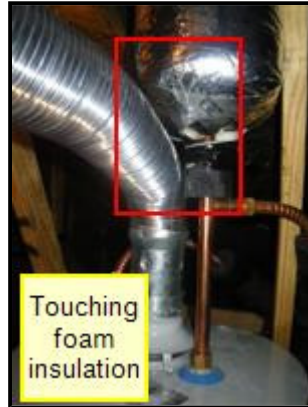
🔧 (3) The water heater vent pipe is too close to combustibile material, and should be serviced before the close of escrow. A single-walled vent pipe should be six inches away from any combustibile material, and a double-walled vent pipe should be one inch away. This construction defect is considered a fire hazard. We recommend that repairs meeting the manufacturers specifications be conducted for fire safety reasons.

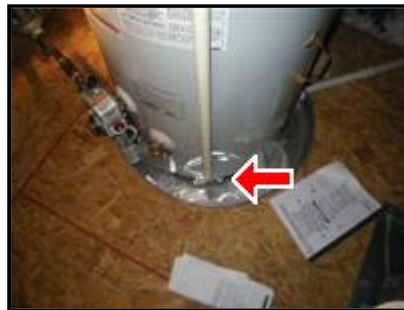
🔧 (4) The discharge pipe from the water heater temperature-pressure relief valve discharges into the water heater drain pan, a common practice which modern construction practices do not allow. Most pans have only a 3/4" diameter drain outlet, which is not capable of gravity draining the pressurized discharge of the relief valve at full flow. The discharge pipe should be plumbed to a conspicuous location at the exterior, to an indirect waste receptor in the same room as the water heater, or to a concrete floor in a conspicuous area where no damage would result. We recommend that the discharge to a floor or the exterior terminate no more than twenty-four inches above grade and no closer than six inches to it.

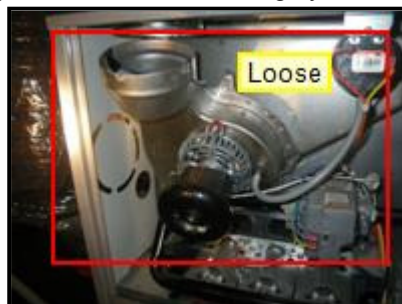
(2) The furnace installation was incomplete. When we removed the cover, the blower fell out. The flue it not connected to the blower, etc. Service by a competent and licensed HVAC contractor is recommended. The furnace system was not tested. The system should be thoroughly tested prior to the close of escrow.

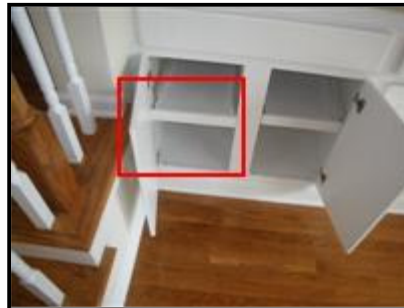
**7.4** The slide-out tray in a family room built-in cabinet is obstructed by the stairs. Service is recommended to modify the installation or remove the tray.

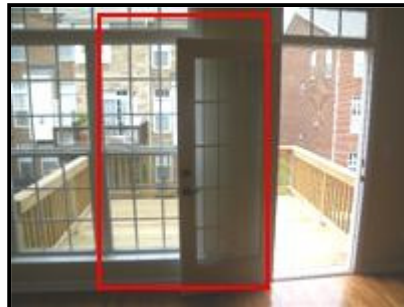
**7.6 (1)** Windows next to the deck entry door did not appear to be tempered glass. According to today's commonly accepted standards, tempered glass is required in windows within 24 inches of a door whose bottom edge is < 60 inches above the floor. Tempered glass is recommended for safety reasons.

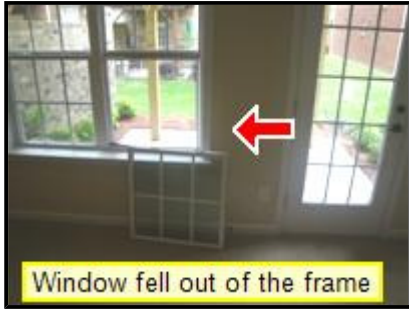
**(2)** One window in the downstairs bedroom has damaged or disconnected components along the frame edge that prevents the window from raising or lowering and/or tilting as designed. Service or replacement within the contingency period is recommended.

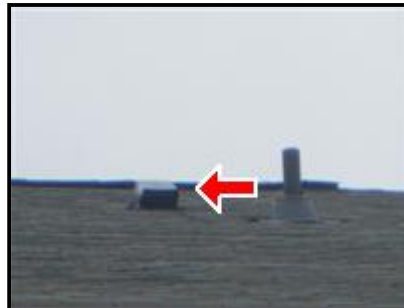
(3) The dryer vent appears to be covered with a screen or grill, which can trap lint and create a clog which would be a fire hazard. Today's commonly accepted construction standards specify a back-draft damper and no screen, and that is what we recommend.
