Alpha & Omega Home Inspections, LLC

Confidential Inspection Report

Property Address: Lot 29 Elm Rd. Charlotte, NC

Date: 7/23/2012	Time: 06:10 PM	Report ID: Pre-Drywall Sample Report
Property: Lot 29 Elm Rd. Charlotte NC	Customer: Mr. Sandy Beach	Real Estate Professional:

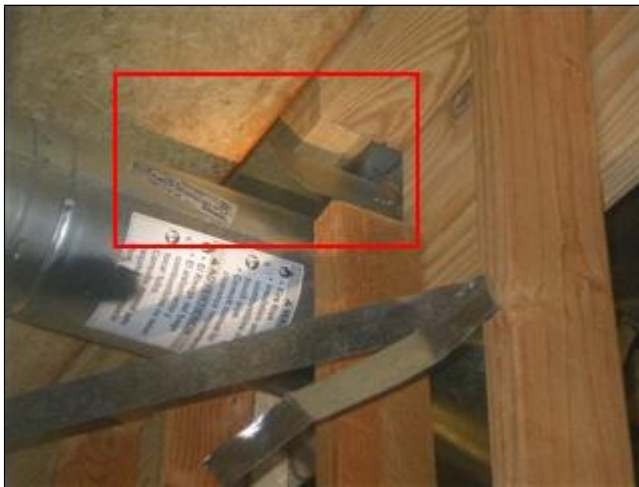
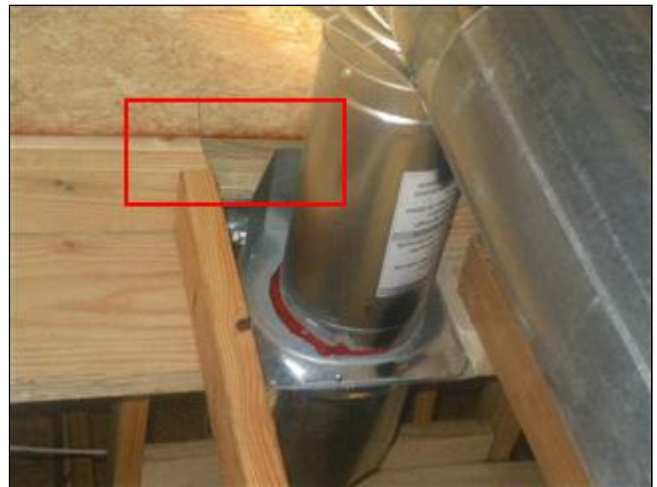
An load bearing wall's top plate and wall stud have been incorrectly altered, cut or pierced. An evaluation and repair as deemed necessary by a licensed and competent general contractor or structural engineer is recommended.

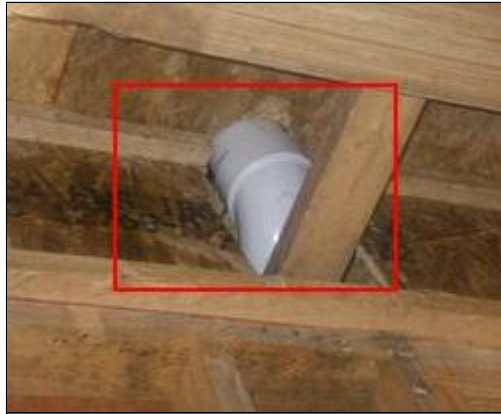
The top or bottom flange of an engineered floor joist(s) has been cut, drilled, damaged, or altered (1st level near the main entrance). Manufactured I-joists are highly engineered components and damage may result in failure of this structural member. While it is permissible to pierce the center web within manufacturer's limits, the top or bottom flange may not be altered. Sometimes damaged flanges can be repaired, however, but any repair must be designed by the manufacturer or a licensed engineer. Whether repairs are possible would depend on the nature and extent of the damage and location of the damage (how far from the ends of the joist). Sometimes repairs cannot be performed and the only solution would be replacement. If repairs are performed, there should be design documents from the manufacturer or an engineer detailing the method of repair. Repairs should be performed by licensed contractors. You should retain those design documents to prove to a subsequent buyer that repairs were performed properly.

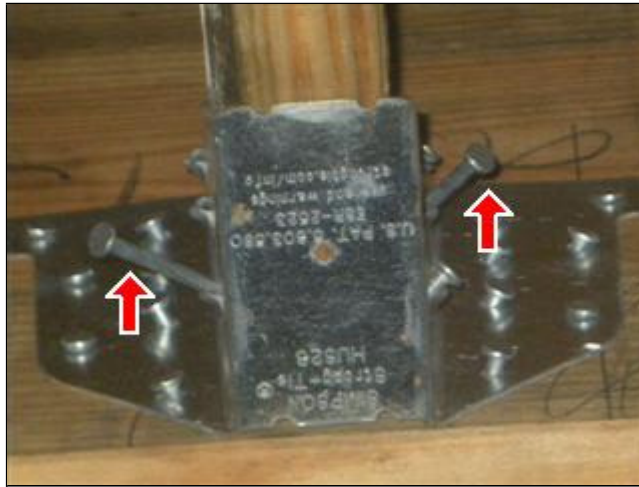
🏠 (1) A truss hanger above the kitchen was not fully nailed and needs minor service.

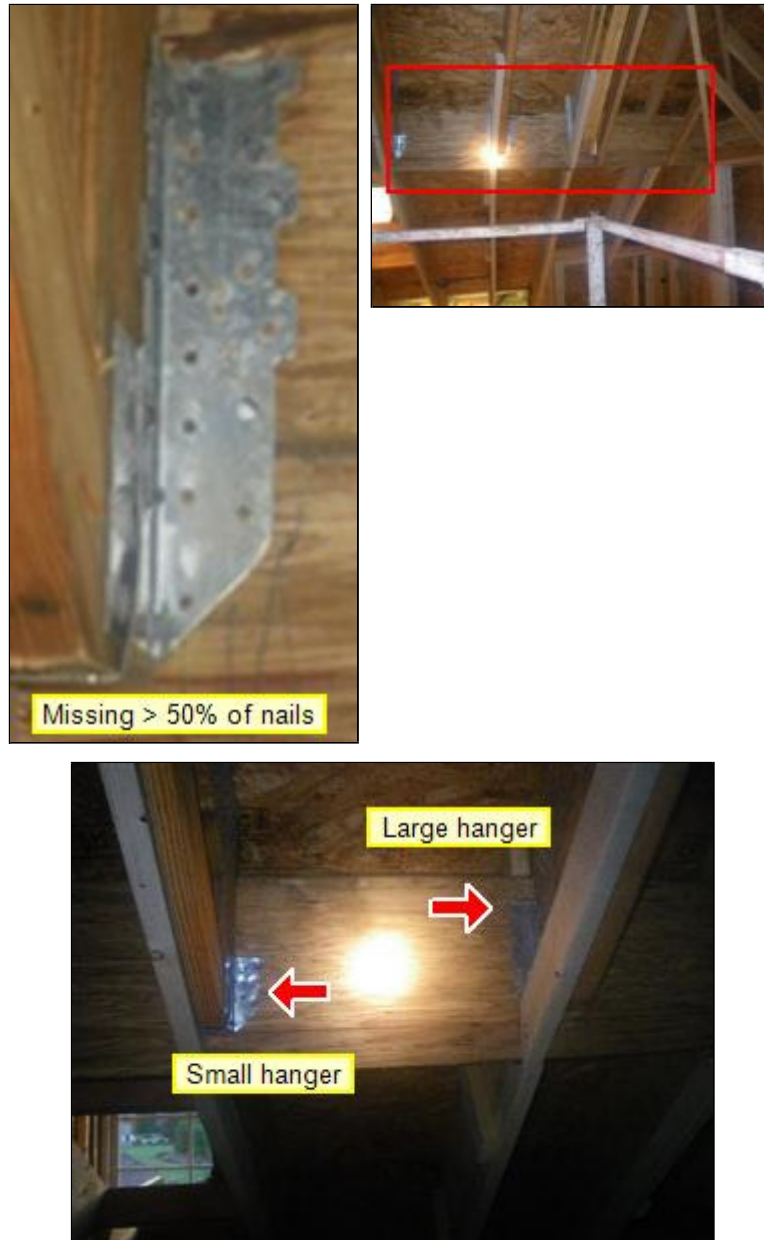
🏠 (2) A truss or beam hanger has been randomly nailed (above entrance foyer). Our understanding is that each round hole in a hanger should be filled with a nail. Service is recommended.

The structure in this area used differing sizes of hangers for the same size truss or beam. We recommend an evaluation to determine if the smaller hangers are the appropriate size.

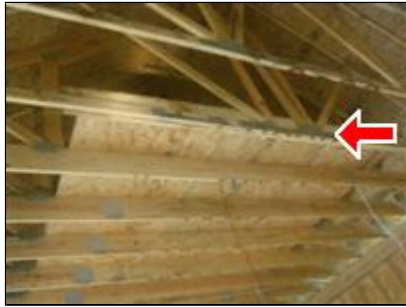
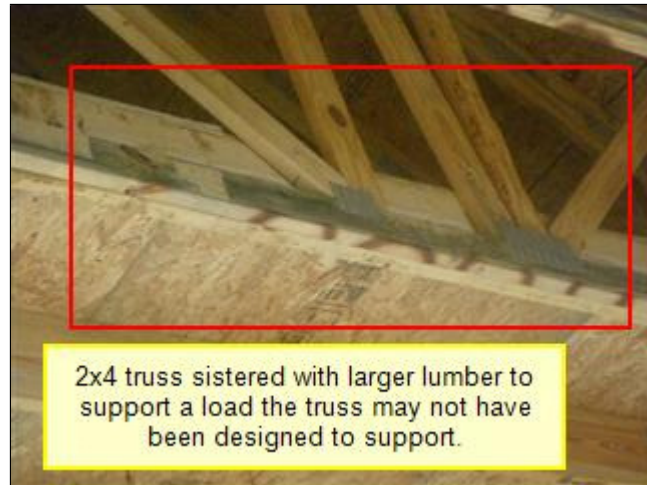
(1) One or more trusses appear to have been modified or altered. Trusses are engineered structural members and any repair or modification should meet the manufacturer's specifications or else be conducted according to the specifications of a structural engineer. Stamped design drawings should exist demonstrating any repairs performed were approved by a licensed engineer. A recommendation is to attach design drawings to the truss to substantiate repairs when the house is sold in the future. We suggest that you consult with the builder, manufacturer of the trusses, or a structural engineer about the adequacy of the roof system's design. Reference documents about trusses and their repair are attached at the end of this report.

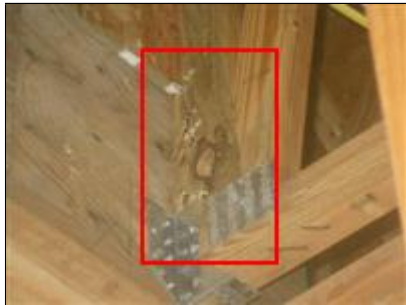
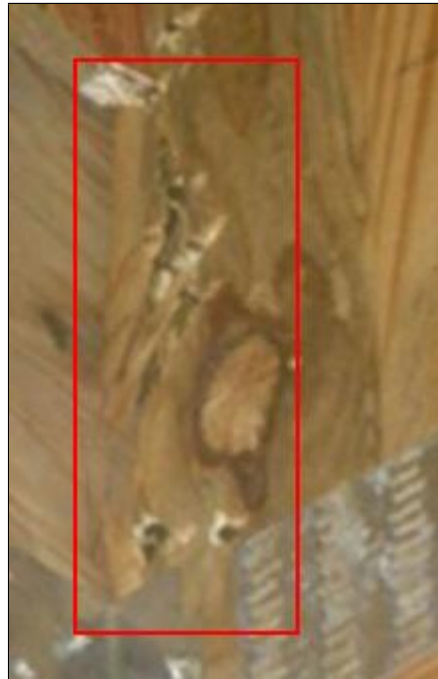
(3) A truss has been moderately damaged by toe nailing above the laundry room. We recommend an evaluation by a licensed engineer and repairs as deemed appropriate.

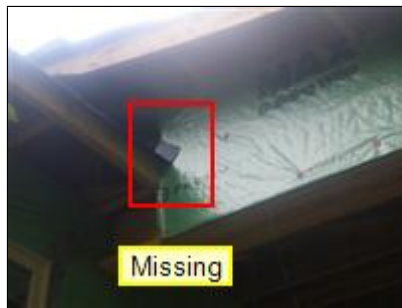
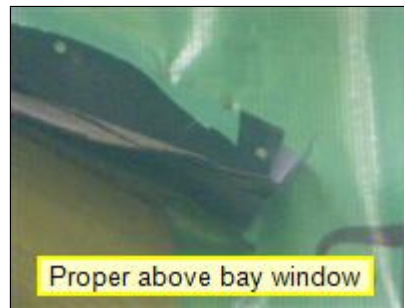
Kickout flashing may be necessary but was not observed at roof to wall transition(s) to divert water away from the wall system and back onto the roof or gutter. Failure to properly manage water flow at these critical transitions may lead to water entry into the wall system, which will cause serious structural damage. An evaluation and repair as deemed necessary by a competent roofing contractor is recommended. A reference document can be viewed [on our website](#).

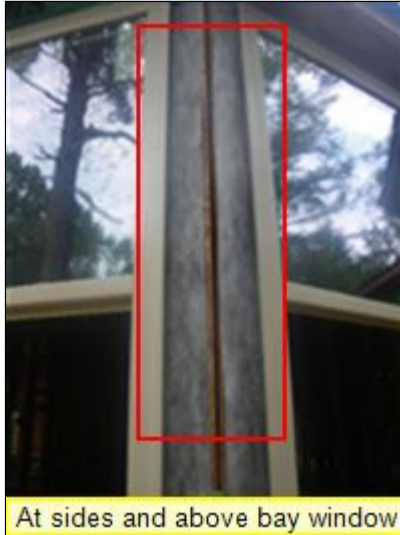
Installation of the required weather resistant barrier ("house wrap") was incomplete.

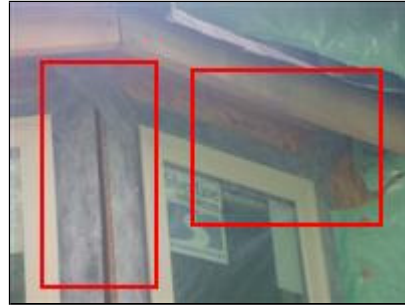
At sides and above bay window

The weather resistant barrier ('house wrap') was not lapped into all sides of the bay window. Most manufacturer's installation instructions specify that the 'house wrap' should lap inside the window opening. You should view window installation instructions and ensure the windows have been installed according to specifications.

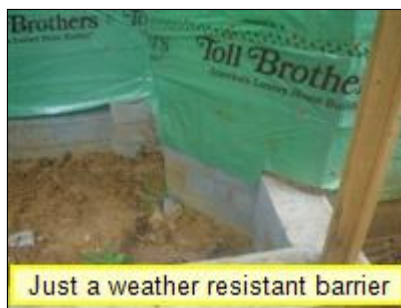
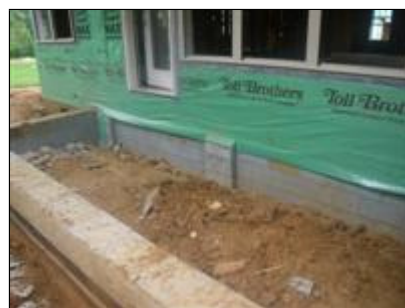
(1) No flashing was present at the front or rear porch. An impermeable barrier is required at the intersection of the porch slab and wall surface. The flashing must be installed prior to the porch slab installation to be effective.

Just a weather resistant barrier

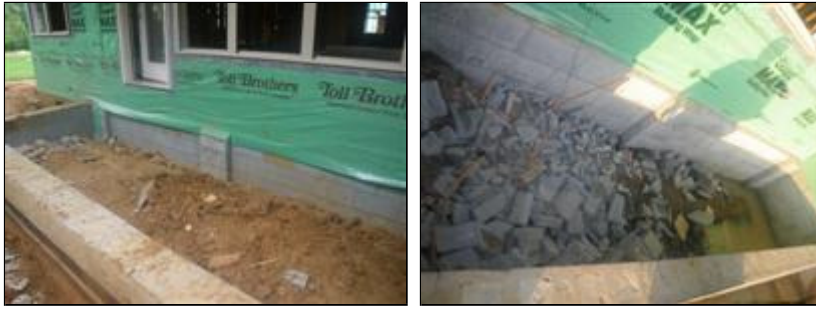
(2) The porches were not provided with access. The interior of the porch may eventually be filled with dirt or organic debris prior to pouring the slab. Dirt or debris filled porches are conducive to termites. Additionally, the inner porch cavity will be un-inspectable for termites whether filled or hollow. We recommend an access opening from the interior of the crawl space for inspection and ventilation purposes.

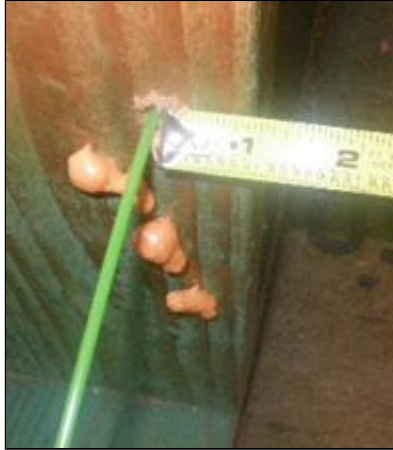
The plumbing for the pest control system in the house walls needs strike protection in many areas to prevent nail or screw damage by the sheetrock installers.

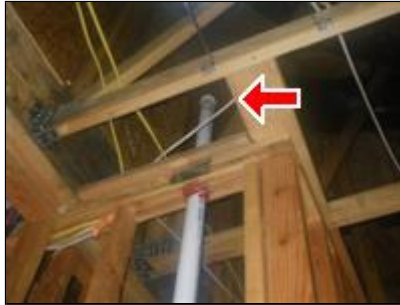
(2) Above the laundry room, an apparent vent pipe is capped and improperly terminates in the attic.

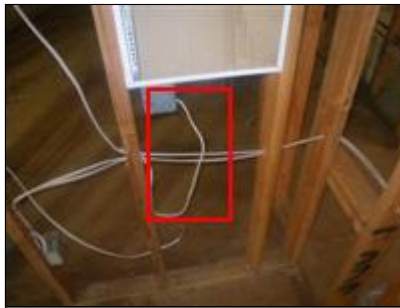
Cables near the laundry room were not supported or secured every 4.5 feet and within 12 inches of every box, cabinet, or fitting.

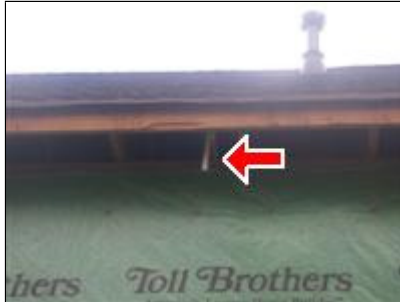
The auxiliary condensate drain does not discharge to a conspicuous location, such as above a window, door, patio, or deck, where any discharge would be readily noticed. We recommend relocation so that it will be obvious when the primary drain clogs and water is draining from the overflow pan in the attic.

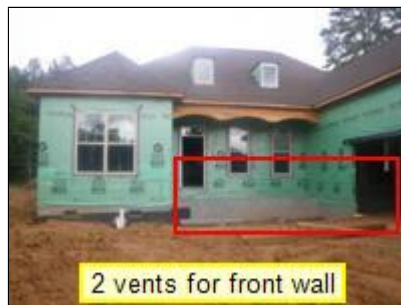
(1) There is limited crawl space ventilation at front of home due to a front porch and the garage. We can elaborate, but at a minimum you should have the crawl space ventilation and wood moisture levels evaluated during humid summer months by a pest control company, home inspector, or other specialist because an increase in crawl space ventilation may be required. A better design would have been to create large openings that would allow access from the main crawl space into the porch cavity and to add vents at the front porch wall and that is what we recommend.

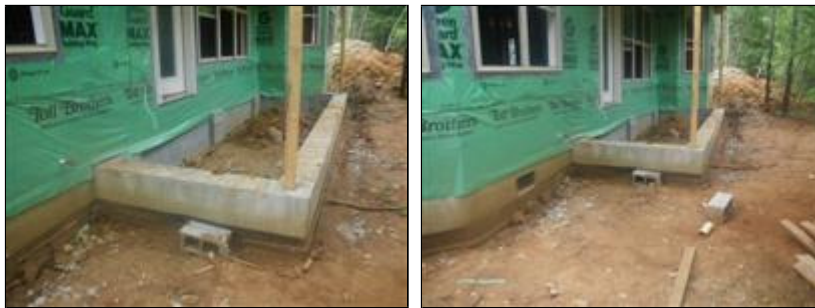
(2) There is limited crawl space ventilation at rear of home due to a rear porch and the garage. We can elaborate, but at a minimum you should have the crawl space ventilation and wood moisture levels evaluated during humid summer months by a pest control company, home inspector, or other specialist because an increase in crawl space ventilation may be required. A better design would have been to create large openings that would allow access from the main crawl space into the porch cavity and to add vents at the rear porch wall and that is what we recommend.
