# **Alpha & Omega Home Inspections, LLC**

## **Confidential Inspection Report**

**Property Address:** 3611 Apple Way Indian Land, SC 29707

<b>Date:</b> 12/7/2011	<b>Time:</b> 03:50 PM	<b>Report ID:</b> Sample Pre-drywall 2
<b>Property:</b> 3611 Apple Way Indian Land SC 29707	<b>Customer:</b> Anita Harecutt	<b>Real Estate Professional:</b>

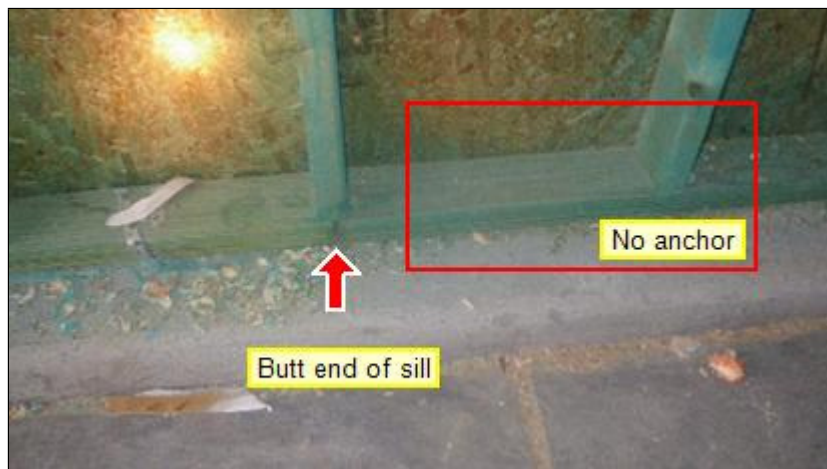
The sill plates were not anchored according to today's commonly accepted construction standards at the garage. Foundations are required to be anchored to the sill plate (base of the outer walls) within 12 inches of the end of each plate and spaced no further than 6 feet apart. The worst case consequence of poorly anchored foundations is movement of the house off the foundation, due to high winds, flood waters, or earth quakes. Repair by a licensed contractor is recommended.

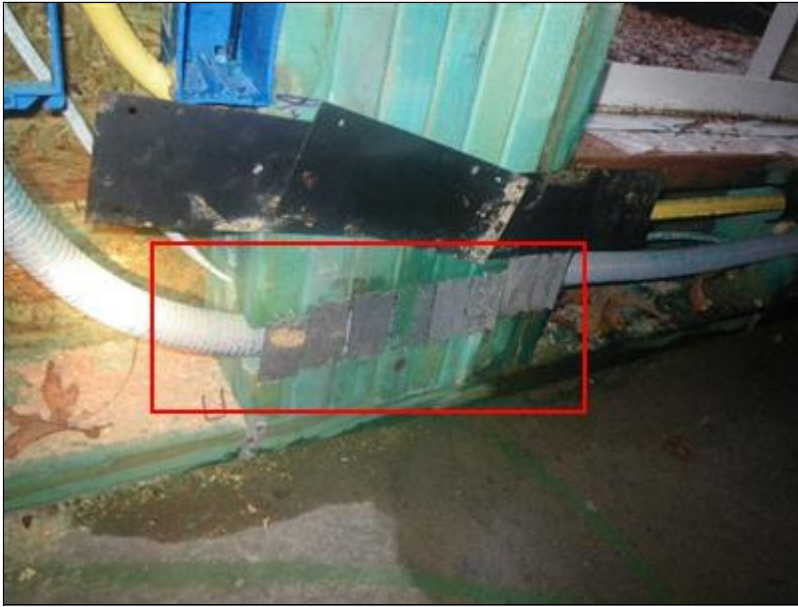
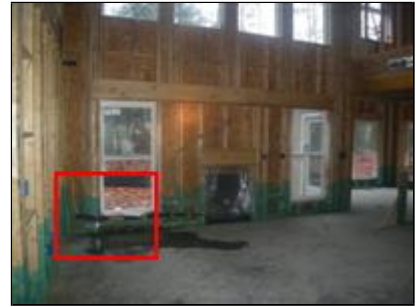
(1) A load bearing wall near the fireplace appears to have been excessively drilled. Today's standards prevent drilling of load bearing walls in excess of 40% of the stud depth. Drilling of more than two doubled studs is prohibited. We recommend a thorough evaluation by a structural engineer and repair compliant with the 2006 International Residential Code. See IRC R602.6.

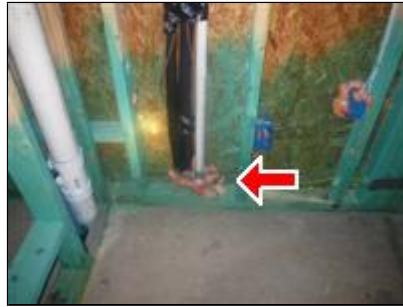
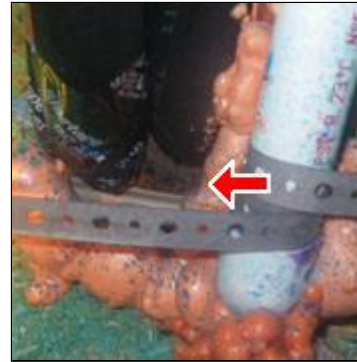
- 🏠 (2) A wall opening at the HVAC line set should be thoroughly sealed to prevent moisture and rodent intrusion.

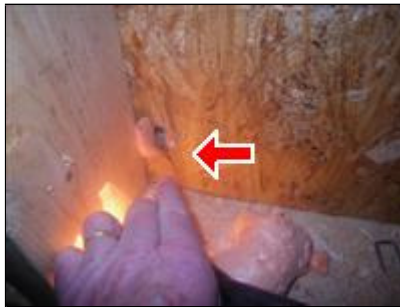
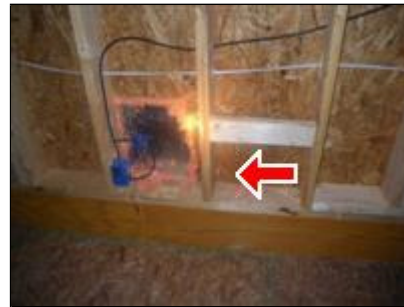
- 🏠 (3) A wall opening at the recreation room should be thoroughly sealed to prevent moisture intrusion.

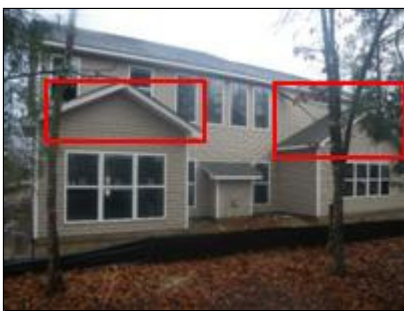
- 🏠 (1) No apparent attic access was provided to the attic above the left rear and left right of the home (1st level). Today's commonly accepted construction standards require an attic access opening for attic spaces with combustible building construction materials where the area is in excess of 30 sq. ft. and the height of the attic is 30 inches or more. The opening should be a minimum of 22 x 30 inches.

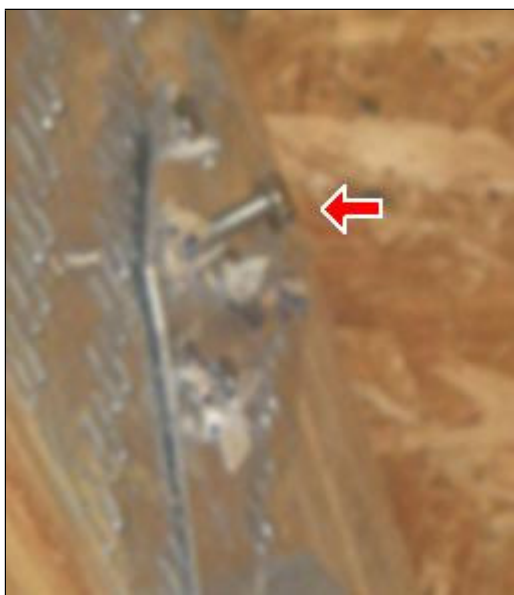
2 Framing hardware in the front center bedroom did not have all nailing holes filled properly. We recommend filling nail holes in the hardware according to the manufacturer s specifications.

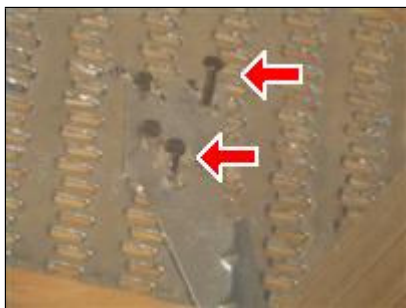
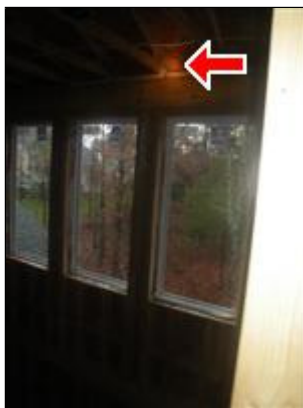
3 Framing hardware in the family room did not have all nailing holes properly filled. We recommend filling nail holes in the hardware according to the manufacturer s specifications.

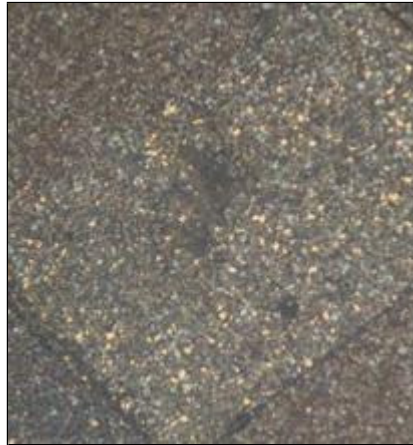
(1) A broken, damaged or torn shingle exists at the right rear of the home.

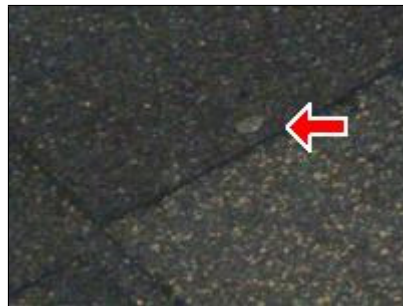
(2) A nail head needs sealant at the right rear roof.

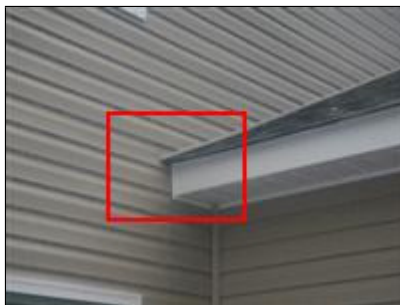
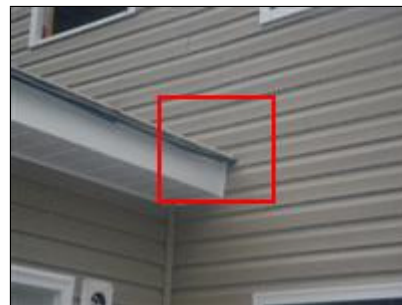
Kickout flashing may be necessary but was not observed at roof to wall transition(s) to divert water away from the wall system and back onto the roof or gutter. Failure to properly manage water flow at these critical transitions may lead to water entry into the wall system, which will cause serious structural damage. An evaluation and repair as deemed necessary by a competent roofing contractor is recommended. A reference document can be viewed [on our website](#).

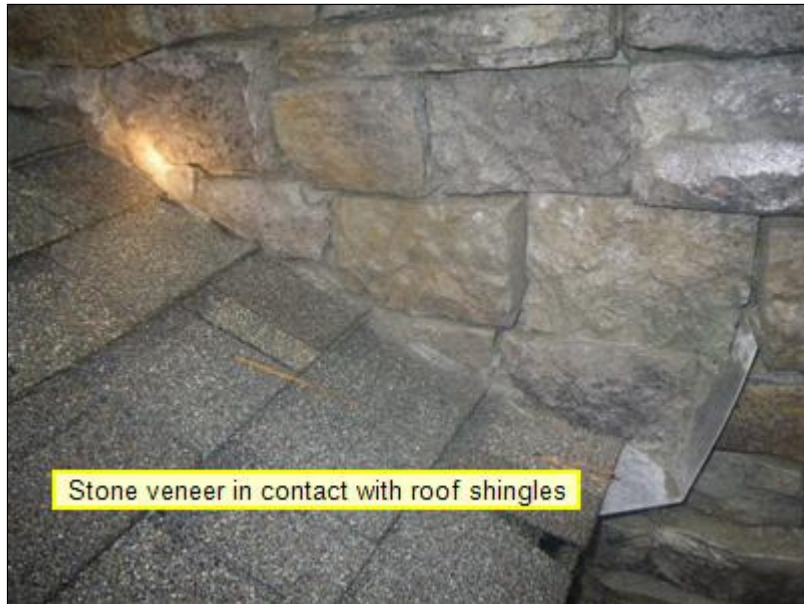
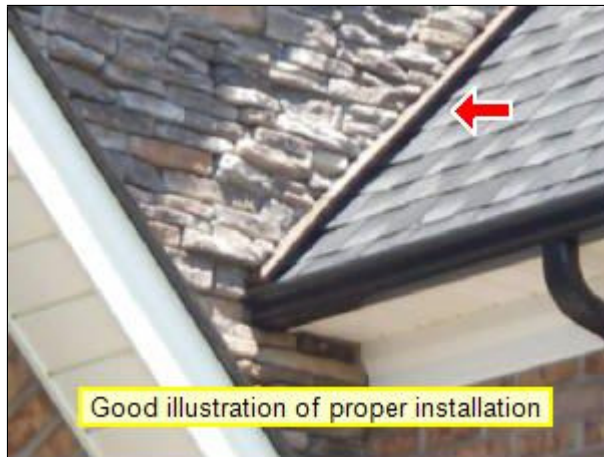
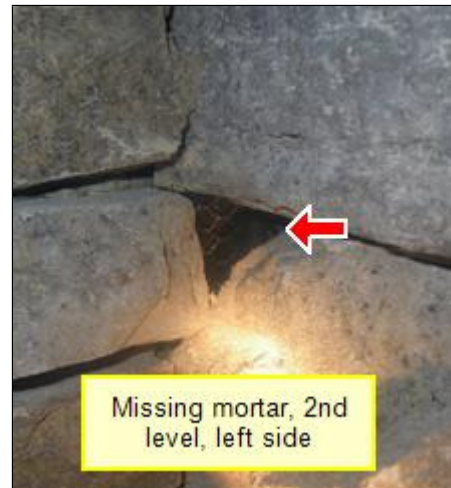
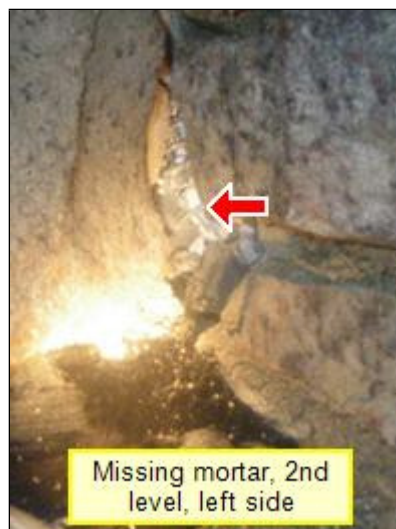
(1) Manufactured stone veneer has been installed on the front of this house. An inspection of the visible components has revealed that the stone veneer has not been installed in compliance with installation guidelines provided by the Masonry Veneer Manufacturer's Association (MVMA). A PDF copy of the installation guidelines is available [on our website](#). The stone manufacturer (Quality Stone Veneer, Inc.) recommends installation according to the guidelines at MVMA. Other resources about this type of siding are available [on our website](#).

Specific problems noted with the visible components include, but may not be limited to: The masonry veneer is in contact with roofing materials. Metal lath is visible between stones, indicating that the proper base coats of mortar were not applied prior to installation of the stone. There is no caulk between other materials and the masonry veneer at windows, doors, and adjacent trim.

The lack of proper detailing and flashing may result in water penetration behind the siding, resulting in structural damage. The installation of the manufactured stone veneer should be evaluated, compared to the specific installation requirements of the stone manufacturer and the MVMA, and repaired or replaced as deemed necessary by a licensed general contractor or masonry contractor experienced with installation requirements for manufactured stone veneer.

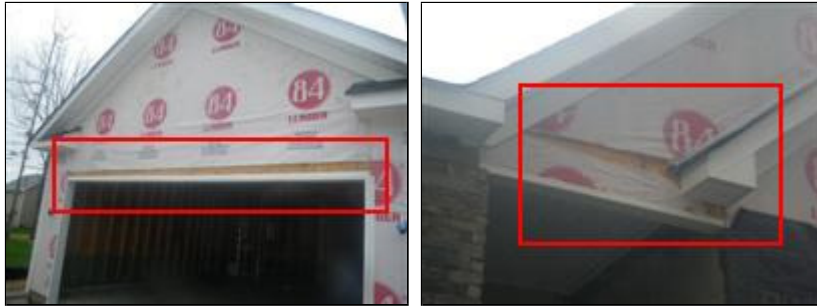
2 Installation of the required weather resistant barrier house wrap was incomplete.

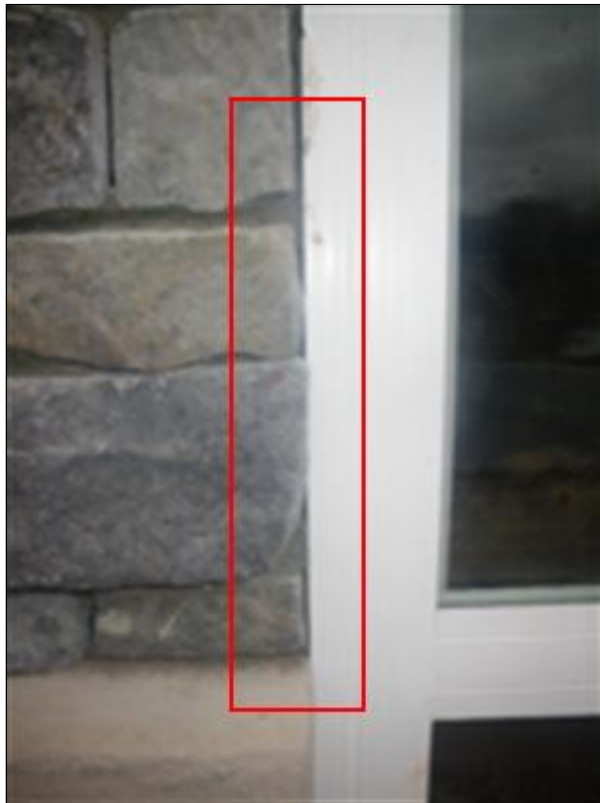
The windows were not installed according to commonly accepted standards and manufacturer installation instructions. Every window manufacturer whose instructions we have viewed requires a gap, typically 1/8", between the window and a stucco veneer (pre-cast stone falls under the stucco installation standards). The gap should be filled with a backer rod and sealant to prevent moisture intrusion. If the gap is not provided, the expansion of the masonry wall during warm weather may cause the window to bind. In the worst case, the window frame may crack and moisture could drain into the wall cavity instead of out the window weeps. We recommend that the windows be installed according to the manufacturer's instructions.

**2009 IRC R612.1 General.** This section prescribes performance and construction requirements for exterior windows and doors installed in walls. Windows and doors shall be installed and flashed in accordance with the manufacturer's written installation instructions. Window and door openings shall be flashed in accordance with Section R703.8. Written installation instructions shall be provided by the manufacturer for each window or door.

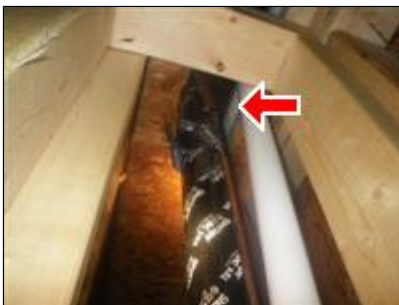
A fire barrier in a closet chase (2nd level bathroom) was not thoroughly sealed to prevent the spread of flames into the attic space.

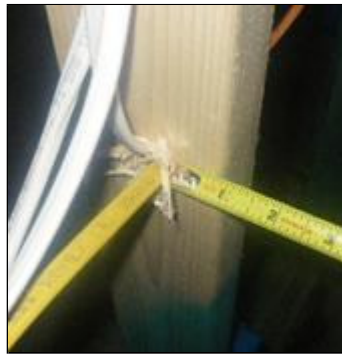
Strike plates were not installed to protect wiring in the dining room less than 1.25" from the edge of the wall stud.

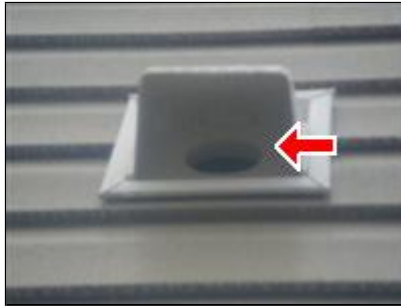
(1) Bathroom exhaust fan ducts were missing back-draft dampers at the exterior.
