# Alpha & Omega Home Inspections, LLC

# Sample Report

104 Blue Ridge Dr.  
Anytown, SC

060805-01

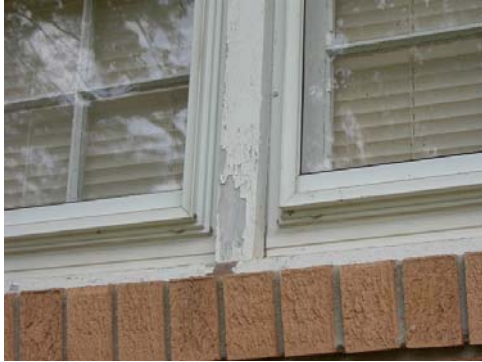
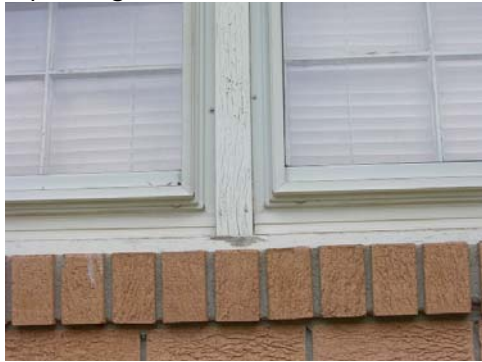
Most window frames had paint cracking and peeling. See below.

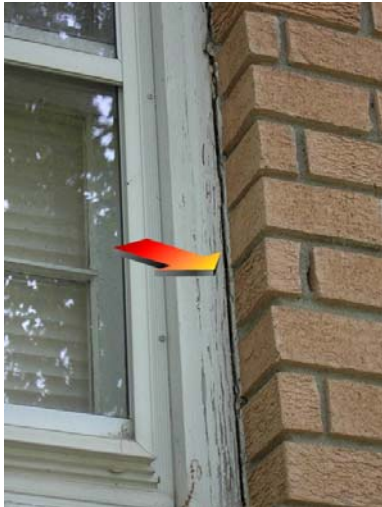
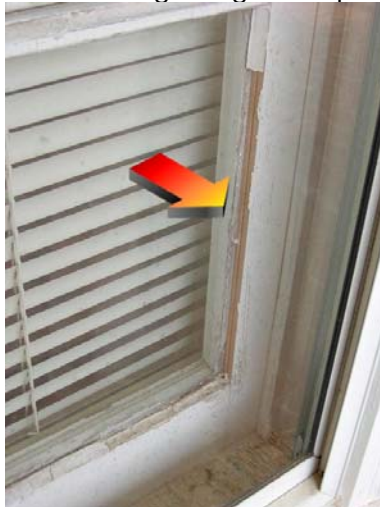
Several windows in need of caulk/putty at frames and glazing. See photos below.

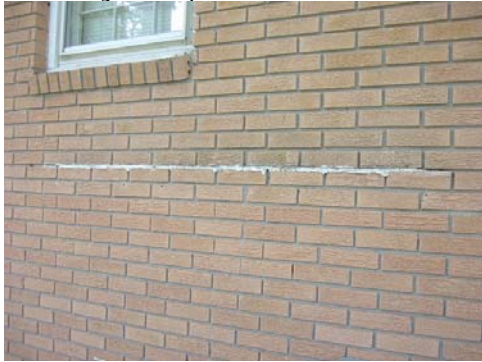
## B-05

Putty was applied to brick mortar at a 5' section above air conditioner. Inspector did not peel back putty to inspect for a crack beneath. Unusual place for putty application. Recommend that buyer inquire as to the reason for this material on the brick wall.

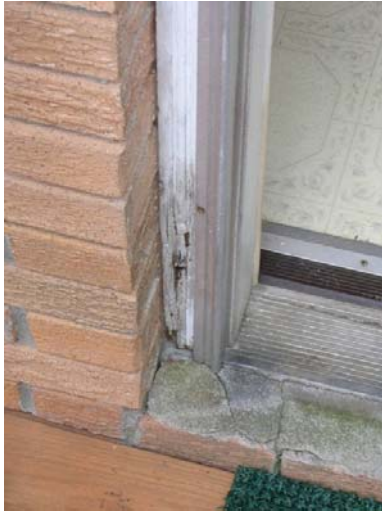
## B-07

1' section of door frame at rear door showed decay at bottom on both sides.

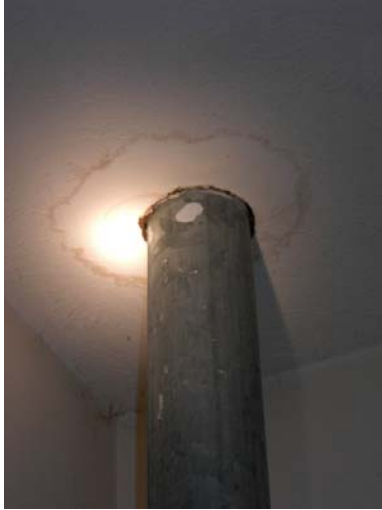
Gas water heater vent touched combustible material (ceiling). Recommend 1" clearance from combustible materials. Ceiling is also apparently water stained at this area, but could not determine if an active leak exists.

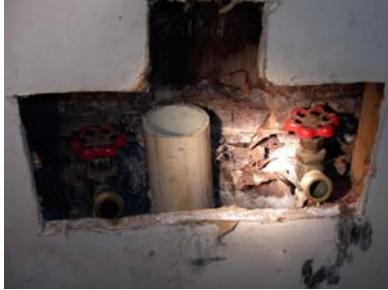
Wall is decayed behind sheetrock at washing machine hookup.

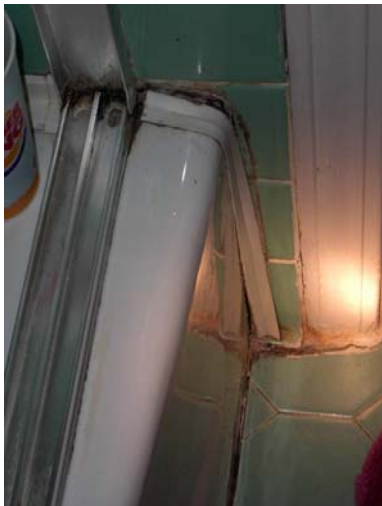
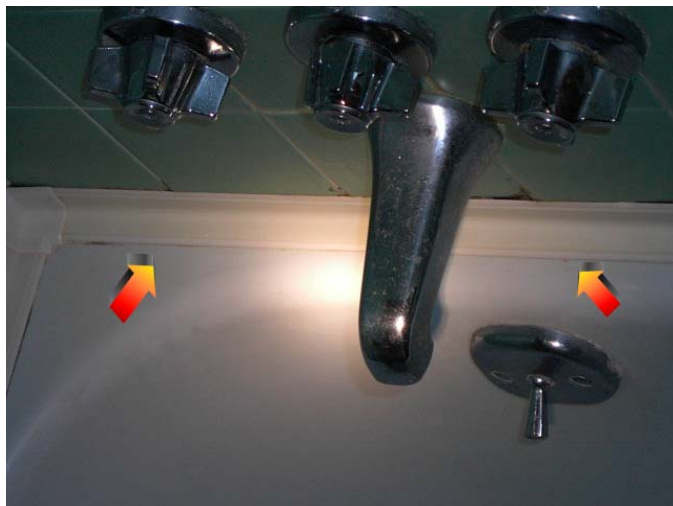
- Bathtub has an unusual water sealer method (rubber-type flexible material). It was loose at tub exterior (see 2 photos below). It is doubtful that this material is water-tight (see Part F in Summary).
- Grout is needed where tub meets floor tile to prevent water from getting to wood beneath.

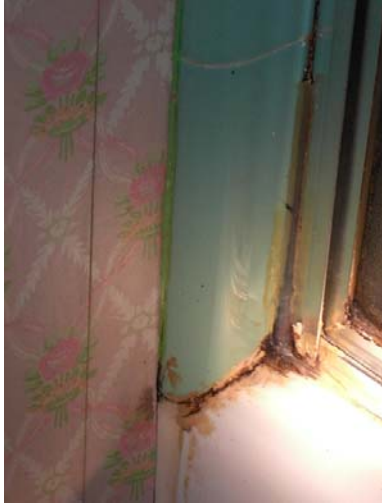
Caulk at tub exterior/rear appears to be ineffective.

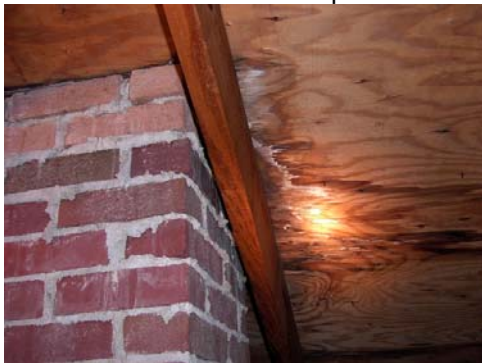
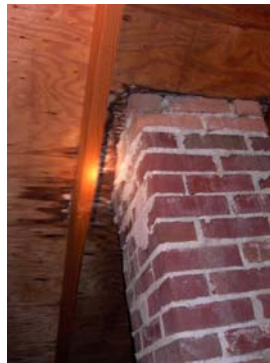
Roof sheathing was water damaged around chimney. Moisture meter detected a higher level of moisture (12%) than surrounding wood (~8%). Chimney flashing or shingles around chimney may be leaking. Chimney, from roof, was noted to be flashed, but not counter flashed. This is common, but not the best installation. Recommend that area be further investigated during/after a period of heavy rain. If leaks exist, recommend a qualified roofer be consulted to make repairs.

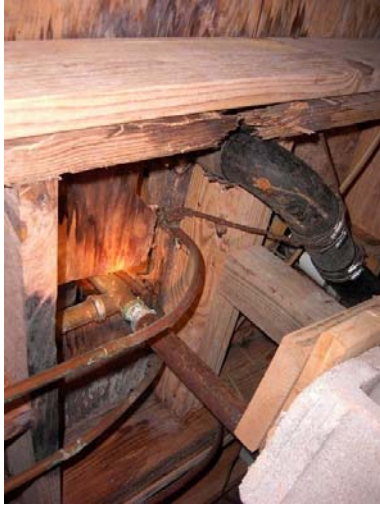
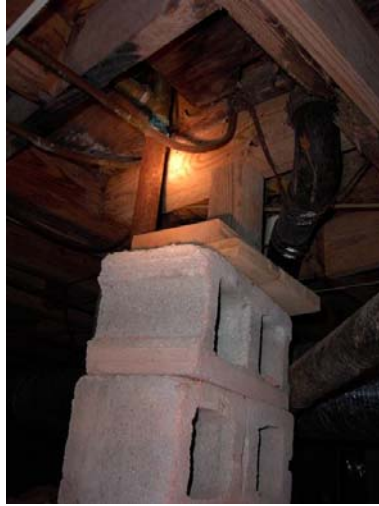
Floor structures under bathroom showed signs of water damage, some decay, and repairs that involved the addition of floor supports (see photo below). Also, repairs involving the addition of floor supports are incorrect, as the concrete blocks are turned in the wrong direction (load supporting side is with holes vertical).

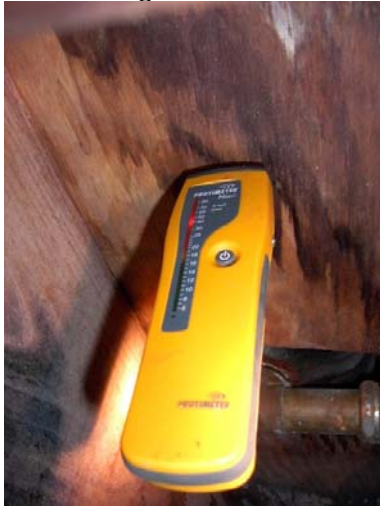
Apparently water leaks still occur, as floor structure was noted to have moisture levels of 50%; a much higher level than surrounding structures (see photo below).

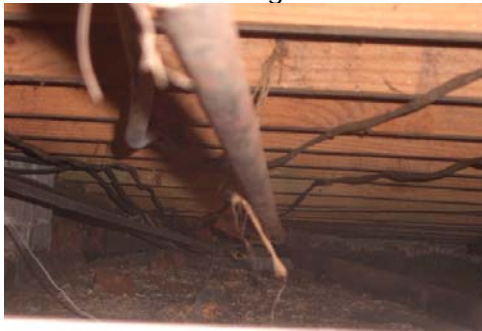
Inspector was unable to access and inspect areas under kitchen and laundry rooms due to low clearances. Untreated wood floor joists in these areas are estimated to be less than 12 inches above ground. Note: today's standards require that untreated wood floor joists be a minimum of 18 inches above ground.
