**Alpha & Omega
Home Inspections, LLC**

CONFIDENTIAL INSPECTION REPORT

227 Ashland Oaks Dr., Catawba, SC 29704

8/24/2006 2:00 pm to 5:30 pm

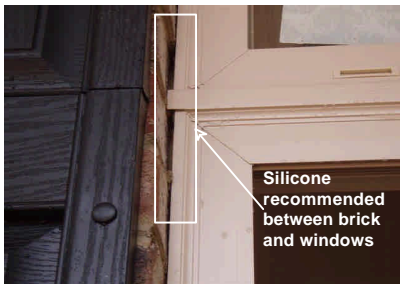
- 2.1 - One or more windows at the brick wall were not adequately sealed to prevent water intrusion. Service is recommended.

- 2.2 - Two arched windows at the deck have open holes that you should view for yourself. Perhaps plugs were provided that were not installed, and we recommend that you consult with the window installer.

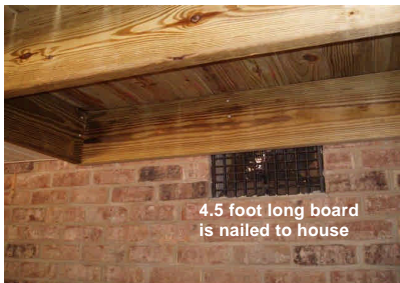
- 2.5 - The wood deck has atypical construction in that a portion of it was nailed to the house and not bolted. We can elaborate on this issue, but you should have a licensed general contractor evaluate it.

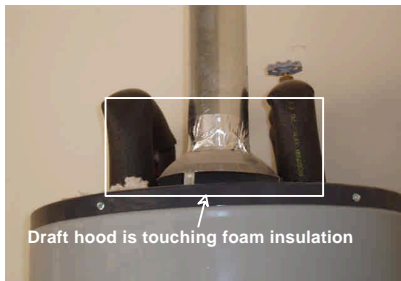
- 4.3 - The vent pipe is too close to combustible material, and should be serviced before the close of escrow. A single-walled vent pipe should be six inches away from any combustible material, and a double-walled vent pipe should be one inch away.

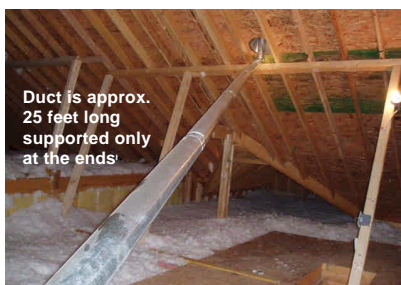
- 4.4 - The gas vent is inadequately supported. Commonly accepted standards state that the vents shall be supported at intervals not to exceed 10 feet by 18 gauge metal straps or 12 gauge metal wire. Service by a licensed plumbing contractor is recommended.

Note: the length of the vent is unusually long and a power exhaust may be necessary, depending on the manufacturer's installation instructions. We recommend that the entire installation of the water heater be reviewed by a plumber other than the one who performed this installation.

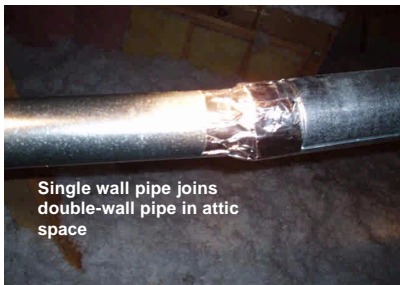
- 4.5 - The water heater vent consists of a single-wall pipe in the attic space, which is prohibited. Service by a licensed plumbing contractor is recommended.

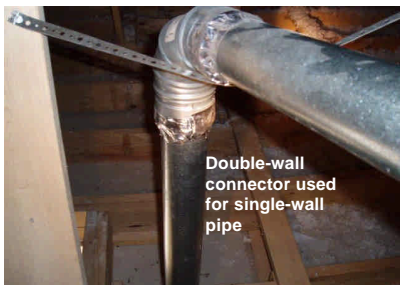
- 4.6 - Improper connections have been made to join single-wall vent pipes. Service by a licensed plumbing contractor is recommended.

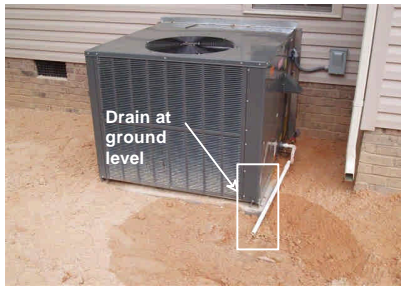
- 7.5 - The condensate drains do not discharge sufficiently above grade. It will likely become clogged as mulch and grass are added. Service to raise the condensate drain is recommended.

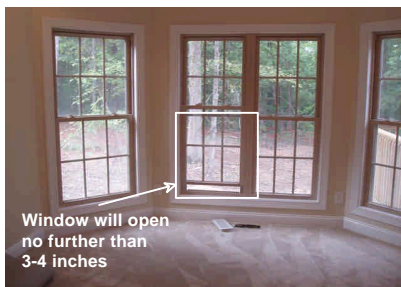
10.1 - A window is damaged and not functional. Service or replacement is recommended.

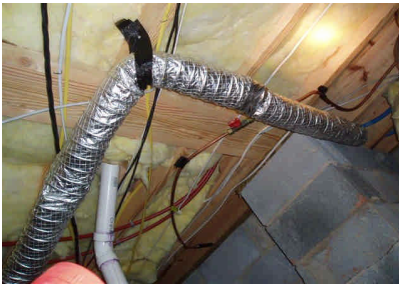
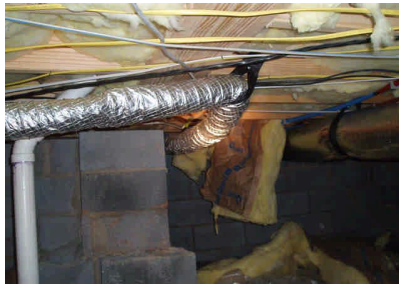
16.1 - The dryer vent in the crawl space was corrugated, flexible ducting. Today's standards for new construction specify that corrugated pipe may be used only within the first 8 feet and may not be concealed within construction. The concealed ducts are required to be rigid metal ducts, vented to the exterior of the home (not inside the crawl space). This is recommended.

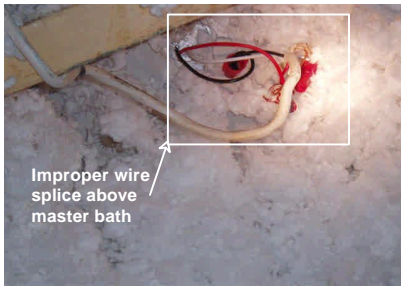
18.1 - One or more electrical connections have been incorrectly made outside of junction boxes. All such connections should be made within junction boxes in order to contain any arcing or sparking that could occur, a task that should be completed by a licensed electrician.
