**Alpha & Omega
Home Inspections, LLC**

CONFIDENTIAL INSPECTION REPORT

12 Cherry Rd., Rock Hill, SC 29730

1/12/2007 9:00 am to 12:45 pm

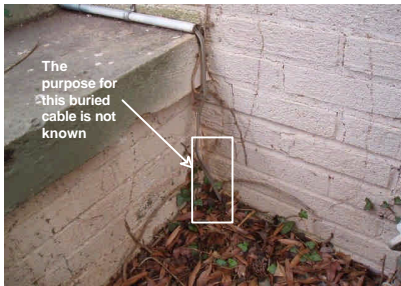
1.2 - Non-metallic sheathed cable was buried underground. An electrician should also confirm that the wiring is approved for exterior and underground use.

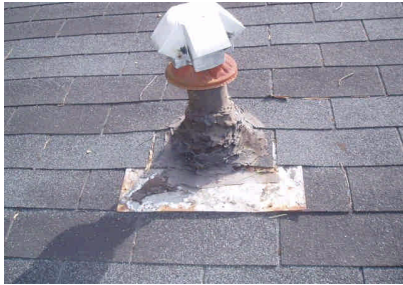
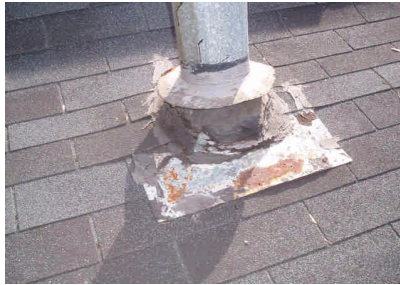
- 2.3 - One or more roof penetrations has been sealed with mastic, instead of conventional metal or plastic flashing, and will need to be monitored. (Replacement is the better option.)

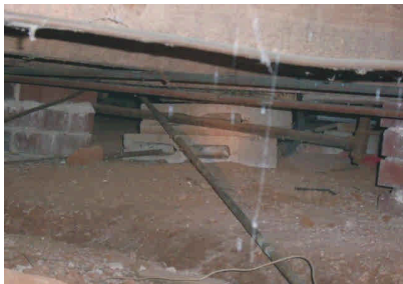
- 3.2 - Floor supports utilize concrete blocks that are installed improperly--the holes in the block should be vertical for load bearing purposes.

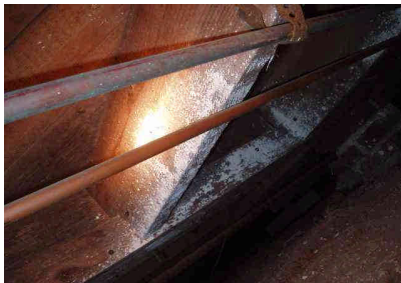
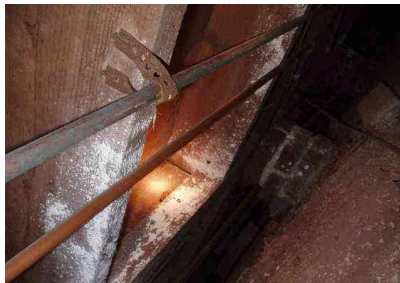
- 3.8 - Moisture content in wood structures was measured at < 20%, but it could be much higher in the humid summer months. No decay was observed, but fungi was noted on floor framing. Wood will decay at moisture levels > 28% and will support fungi growth at levels in the low-20s. It is recommended that a qualified individual: 1) remediate (kill) the fungi growing in the crawl space, 2) take appropriate measures to eliminate the environment conducive to future fungi growth. The services of a mold remediation specialist and/or a crawl space specialist should be considered to achieve the desired results. Options to reduce the moisture levels include, but are not limited to, elimination of water intrusion into the crawl space, increasing ventilation, installation of a vapor barrier or installation of a humidistat controlled fan. Here's useful information from the EPA about fungi: <http://www.epa.gov/mold/moldresources.html>

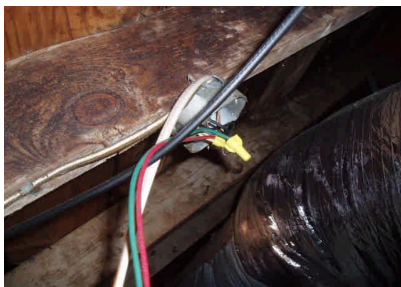
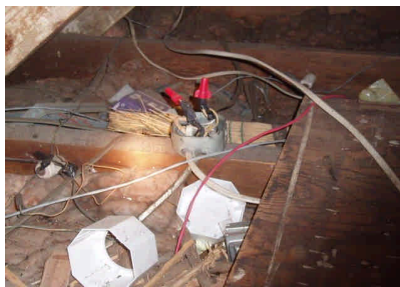
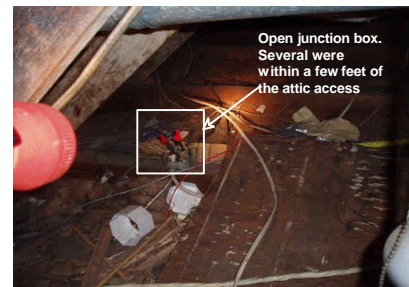
4.2 - There are one or more open electrical junction boxes, which should be sealed to contain any arcing or sparking that might occur.

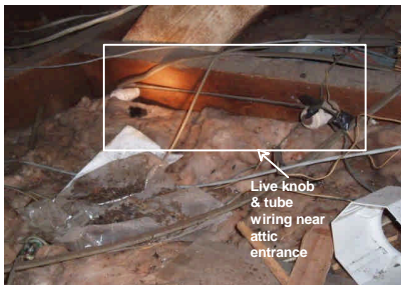
4.3 - Obsolete and suspect knob and tube wiring is present, which should be inspected and certified as safe, or replaced by a licensed electrician.

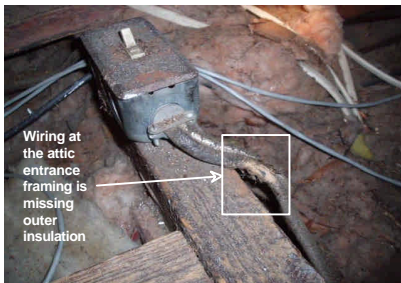
4.4 - There are unprotected electrical conductors within six feet of the attic access. Today's standards for new construction prohibit this practice and we recommend that they be relocated for safety reasons.

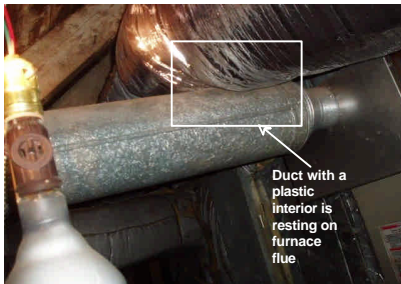
- 9.5 - The furnace exhaust flue was in contact with or too close to combustible materials. The manufacturer of the vent (a "B-vent") recommends a minimum 1" clearance from combustible materials. This construction defect is considered a fire hazard. We recommend that repairs meeting the manufacturers specifications be conducted for fire safety reasons.

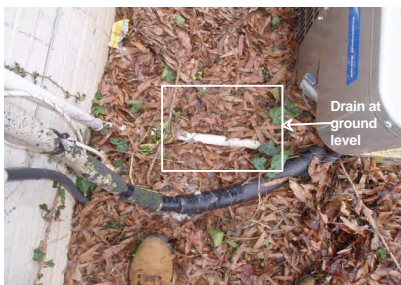
- 9.6 - The condensate drain(s) do not discharge sufficiently above grade. It will likely become clogged. Service to raise the condensate drain(s) is recommended.
